# Performance Evaluation of Concrete Surface Treatment Materials

A Thesis Presented to the

KING FAHD UNIVERSITY OF PETROLEUM & MINERALS

June, 1996

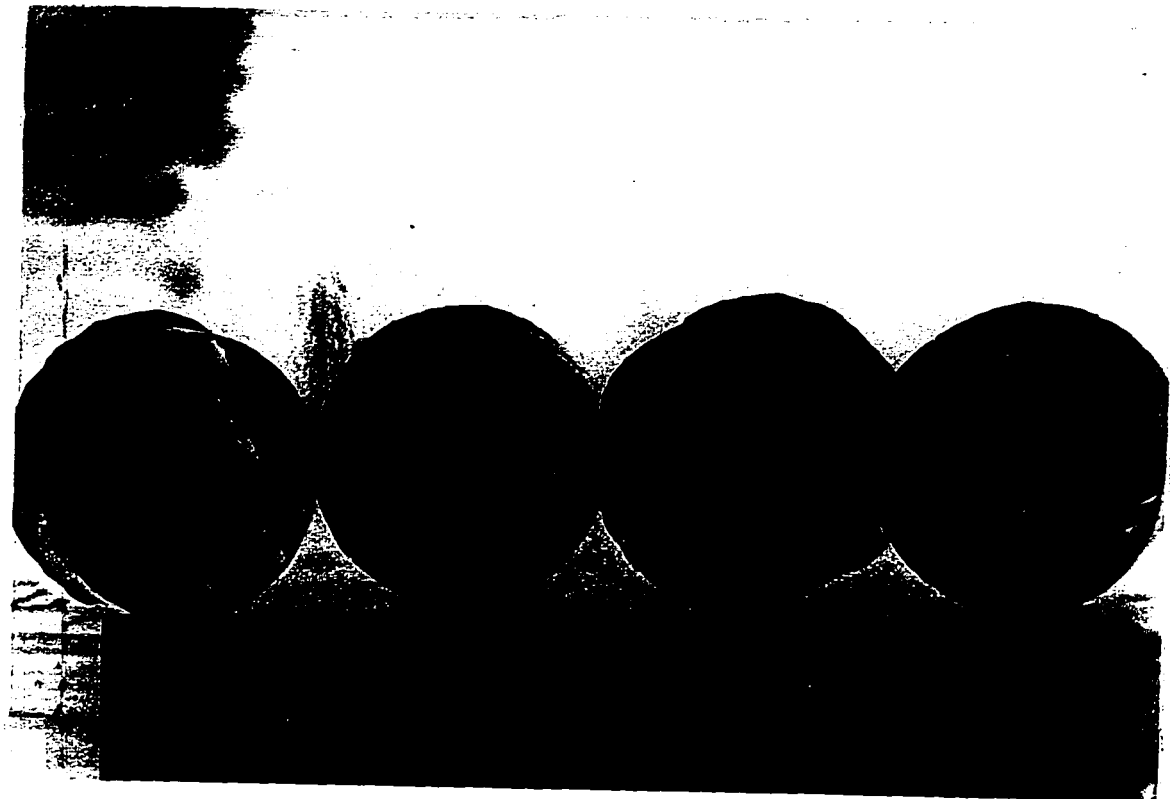
Plate 4.7.3 : Carbonation in the Concrete Specimens Coated with Silane/Siloxane with Top Coat

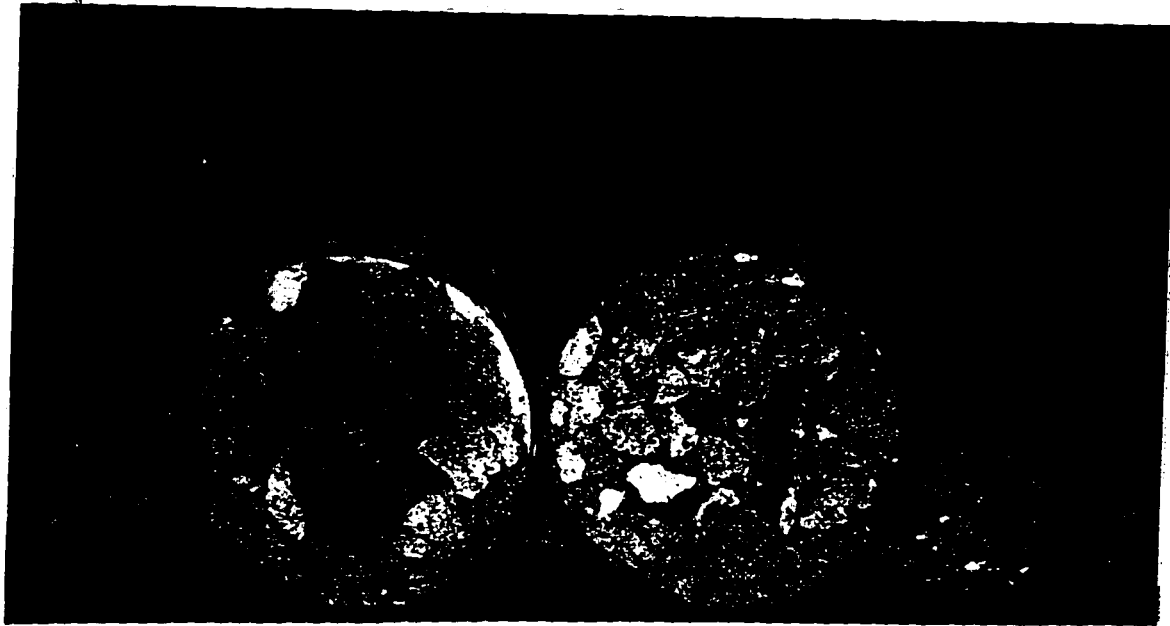
## **SILANE SILOXANE (S3)**

Plate 4.7.7 : Carbonation in the Concrete Specimens Coated with Silane/Siloxane
